Vector3に関するご案内

NO. : 1834 Rev A

宛先： Vector 3のお客様各位
日付： 2018年6月14日
件名： Vector 3のハードウェア点検実施のお願い

TO: Vector 3 Customers
DATE: June 14, 2018
SUBJECT: Vector 3 Requires Hardware Inspection

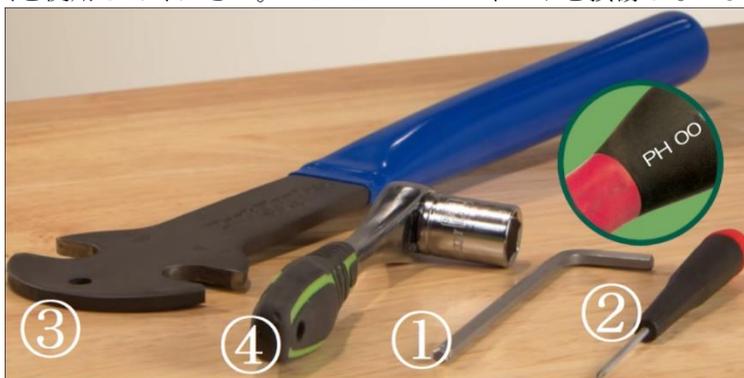
- ① 4 mmの六角レンチ
- ② PH 00ドライバー
- ③ 15 mmのペダルレンチ
- ④ 外径が17 mm未満の12 mmソケットレンチ（通常は $\frac{1}{4}$ in. のドライブソケット）

注意：片方ずつペダルのスピンドルナットを締めることをお勧めします。このとき、小さな部品を紛失しないようご注意ください。下記の工具を使用してください。Vectorコンポーネントを損傷しないように注意してください。

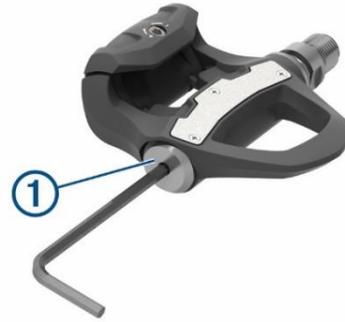
1. バッテリーカバー①とバッテリー②を外します。

Vector 3をお使いのすべてのお客様に対して、新設計のバッテリーカバーを無償でご用意しています。詳細については、Garmin製品サポート (<https://support.garmin.com/ja-JP/>) にお問い合わせください。

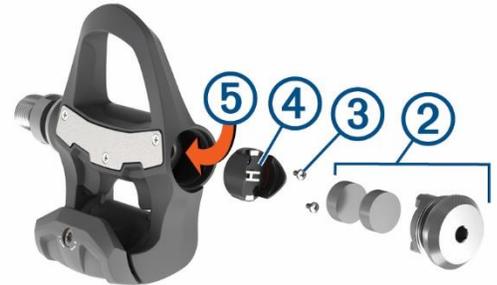
2. 小さな+ドライバー (PH 00) を使用して、2本のネジ③をバッテリーキャリア④の内側から取り外します。

3. バッテリーキャリアを取り外します。
4. ペダルレンチでレンチフラットをしっかりと保持したまま、12 mmソケットレンチを使用してスピンドルナット⑤を7 lbf-ft. (10 N-m) 締め付けます。

注意：スピンドルナットが所定の位置に留まるように、推奨のトルク仕様に従って締め付けを行ってください。

注意：右側のペダルでは、スピンドルナットの色は黒で、ネジ山の方向が逆になります。左側のペダルでは、スピンドルナットの色は銀です。左側のスピンドルには、レンチフラット部にラインがあります。

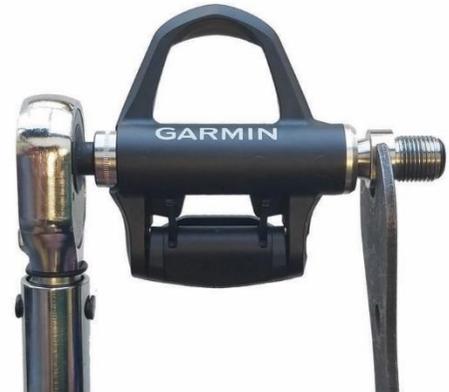
7. 4 mmの六角レンチを使用して、バッテリーカバーを軽く締め付けます。

注意：バッテリーカバーを締め過ぎないようにしてください。黄色のOリングガasketが見えなくなれば、カバーの締め付けは十分です。ペダルのLEDが一度赤く点滅します。

5. バッテリーキャリアと2本のネジを締めます。
6. バッテリーとバッテリーカバーを交換し、手で締めます。

注意：黄色のOリングガasketを傷つけたり、紛失したりしないようにしてください。

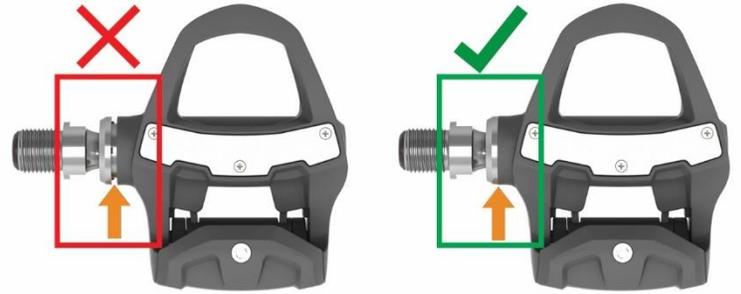
1. ペダル本体とカートリッジの接続部分を確認します。
ペダル本体とカートリッジの接続部に隙間がある場合、センサーの性能低下、リセット、または回転への影響の原因となります。
2. 隙間が見えている場合、Garmin製品サポート (<https://support.garmin.com/ja-JP/>) にご連絡ください。

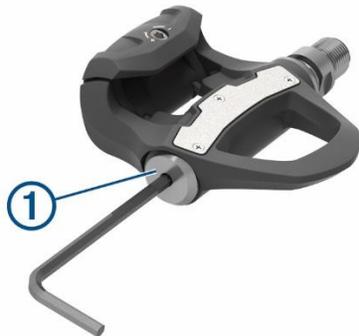
3. Use a 4 mm hex key to remove the battery cover (1).

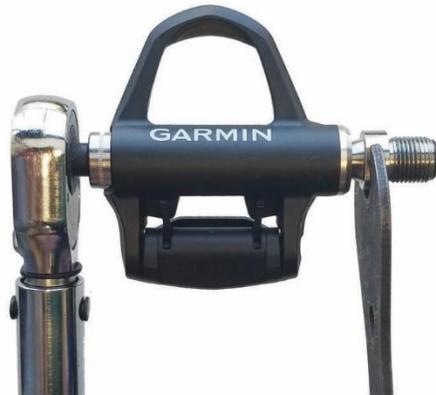
5. Use a small Phillips screwdriver (PH 00) to remove the two screws (3) from inside the battery carriage (4).
NOTE: If you have the Vector 3S system, the right pedal has no battery carriage.
6. Remove the battery carriage.
7. While securely holding the wrench flats with a pedal wrench, use the 12 mm socket wrench to torque the spindle nut (5) to 7 lbf-ft. (10 N-m).
NOTE: To ensure that the spindle nut stays in place, you must tighten it to the recommended torque specification.
NOTE: The right pedal has a black spindle nut and a reverse thread. The left pedal has a silver spindle nut. The left spindle has a line on the wrench flats.

8. Replace the battery carriage and two screws.
9. Replace the batteries and battery cover, and hand tighten it.
NOTE: Do not damage or lose the yellow O-ring gasket.
10. Use a 4 mm hex key to gently tighten the battery cover.
NOTE: Do not over-tighten the battery cover. The cover is sufficiently tight when the yellow O-ring gasket is no longer visible.
 The pedal LED flashes red once.

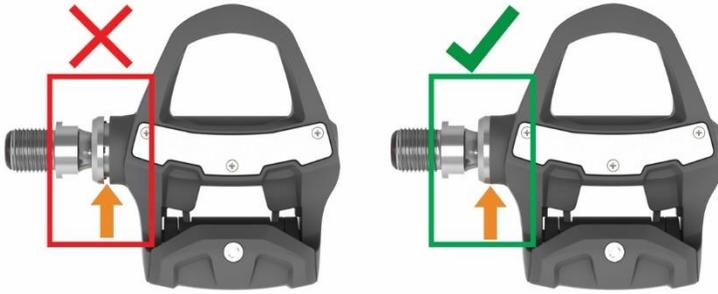
1. Examine the area where the pedal body connects to the cartridge.
 If there is any separation between the pedal body and the cartridge, you could experience poor sensor performance, resets, or resistance to rotation.

2. If any separation is visible, contact Garmin Product Support at support.garmin.com.
